### Guide to Seals, Bearings, and Couplings

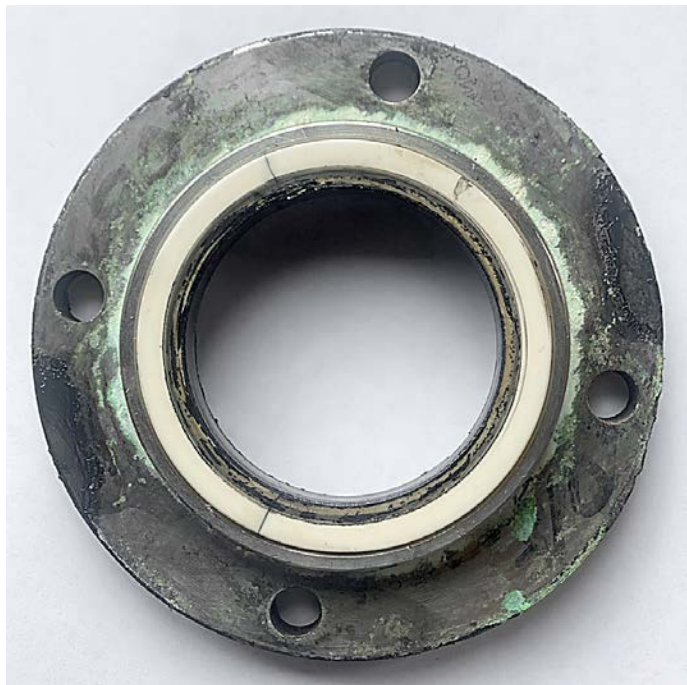
Viscous fluids such as paint can cause build up along the faces and edges of the seal. Over time, this can cause failure. See **Figure 1** for an example of a seal that failed due to paint buildup.

**Figure 1 Failed mechanical seal exhibiting cracked seal faces and paint buildup**
